Technical support guide

General information

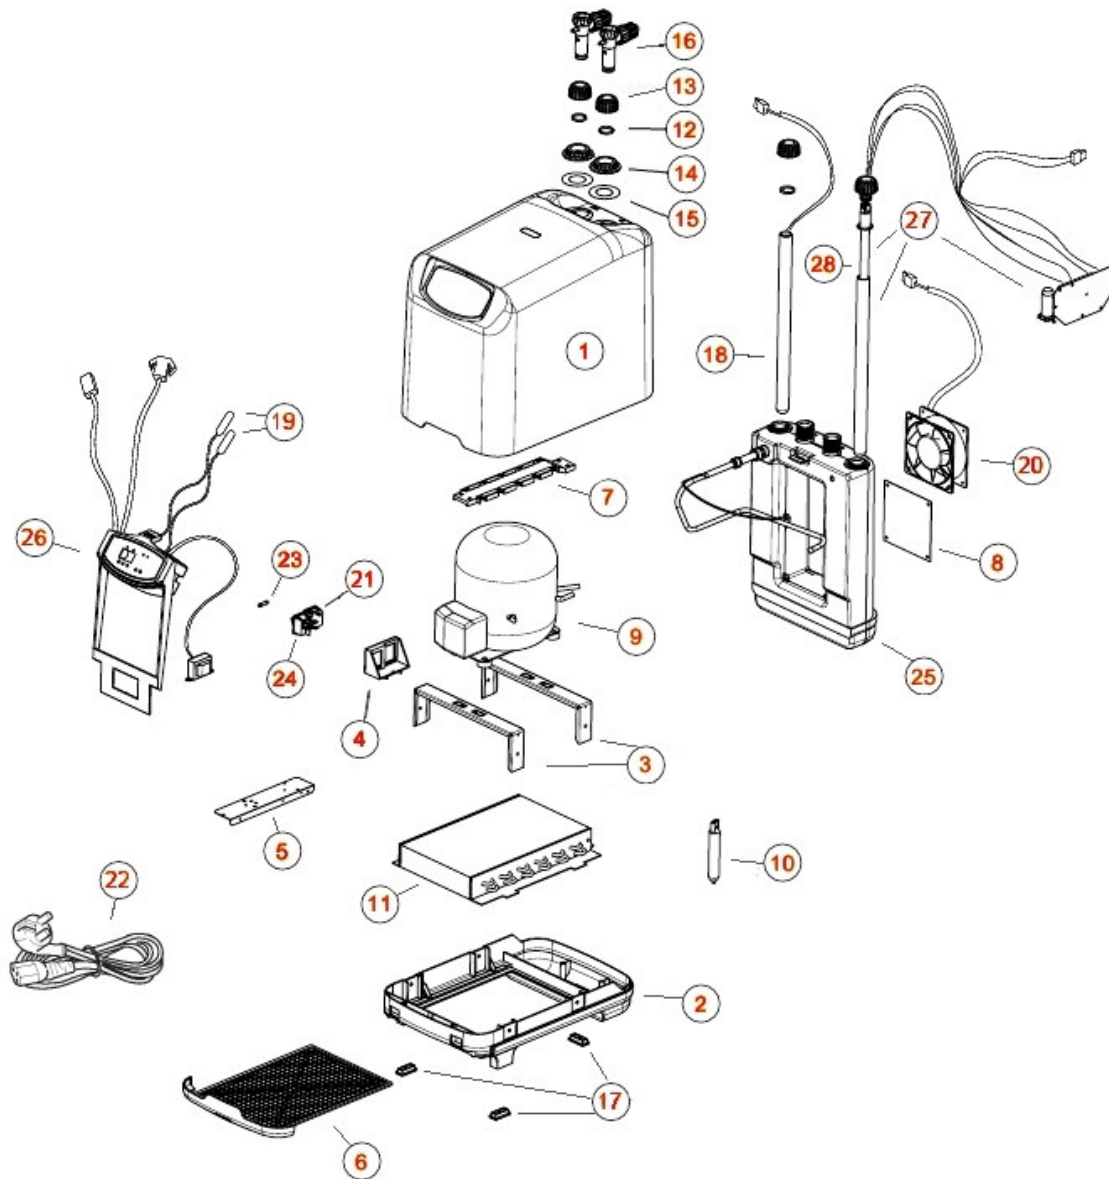
- switch off the chiller pushing the on/off button (19)
- disconnect the supply cable (23)
- close the taps of water inlet and outlet (16) and unscrew the ring nuts (13)
- unscrew the fairing ring nuts (14) and pull out the air filter (6)
- pull the bottom of the fairing from the frontal part in order to separate it from the base (picture A)
